# **WATER QUALITY MONITORING IN THE HOOVER CREEK WATERSHED 2004-2006**

**Iowa Geological Survey  
Technical Information Series No. 53**

**September 2007**

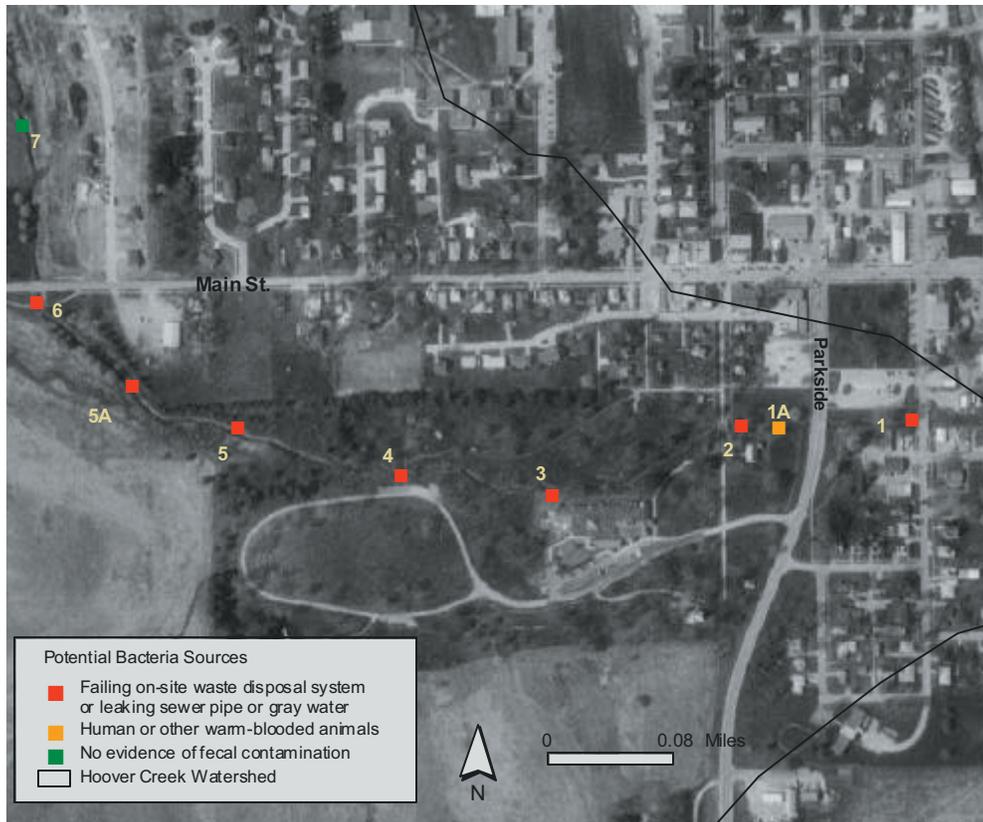
**Figure 11.** Potential sources of bacteria in Hoover Creek as it flows into the Herbert Hoover National Historic Site based on targeted bacteria sampling results. Results plotted over a digital orthophoto quadrangle (DOQ).

contaminated by bacteria as a result of a failing on-site disposal system, a leaking sewer pipe, or gray water (Figure 11). Sites outside of the park boundaries are characterized as having bacteria that is potentially from humans or other warm-blooded animals as well as failing waste disposal systems.
