Investigation of a Recharge Basin to Improve Drought Resiliency and Aquifer Sustainability

Rock Valley Rural Water

Water Resources Investigation Report 15

Iowa Geological Survey
Water Resources Investigation Report 15

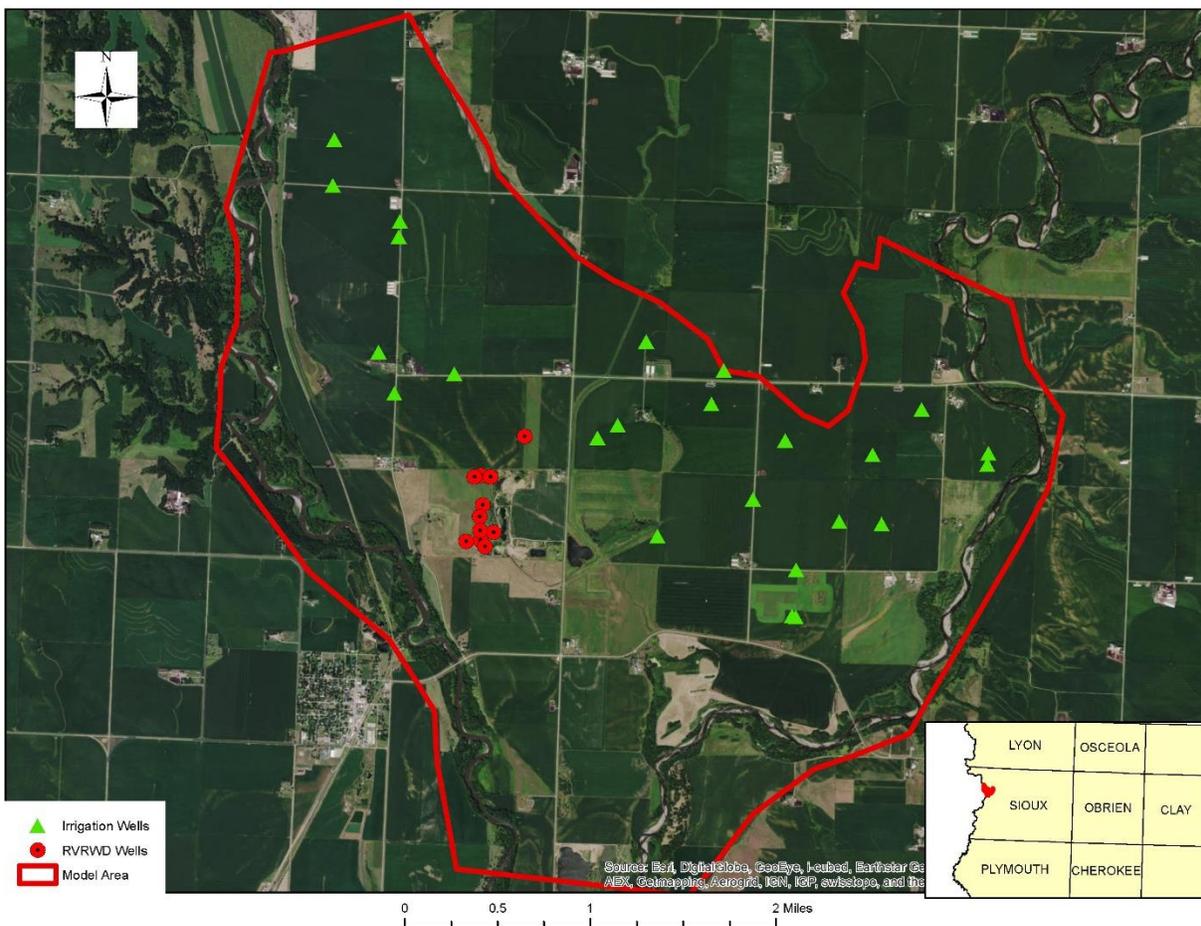
Figure 1. Rock Valley Rural Water District location and model extent.

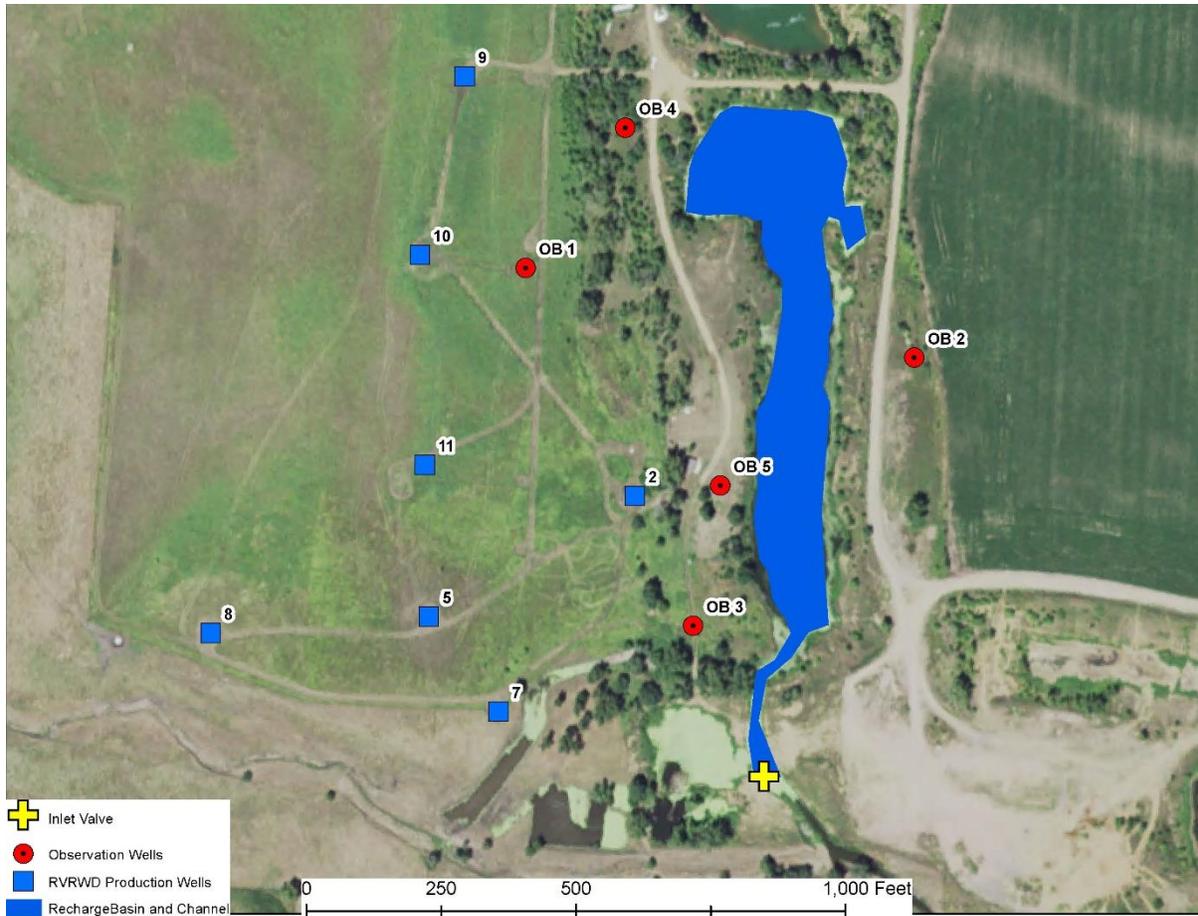
Figure 2. Sand and gravel quarry location used as a recharge basin. Unnamed Creek was re-routed into the quarry.

An engineered recharge basin was designed by DGR Engineering, Inc., and constructed in the former sand and gravel pit near RVRWD during the fall of 2013. Permits were acquired by the IDNR and the U.S. Corps of Engineers. As part of this design, a small Unnamed Creek (17 square mile drainage area) was diverted into the recharge basin. On June 17, 2014, surface water from the Unnamed Creek began to fill the basin. Over the next 3 months, groundwater elevations rose approximately 11 to 15 feet in the RVRWD wellfield. This additional recharge allowed RVRWD to maintain water production from its 11 shallow wells. However, important questions still remain regarding the duration of this benefit during an extended drought and the potential impacts of this induced recharge on water quality.

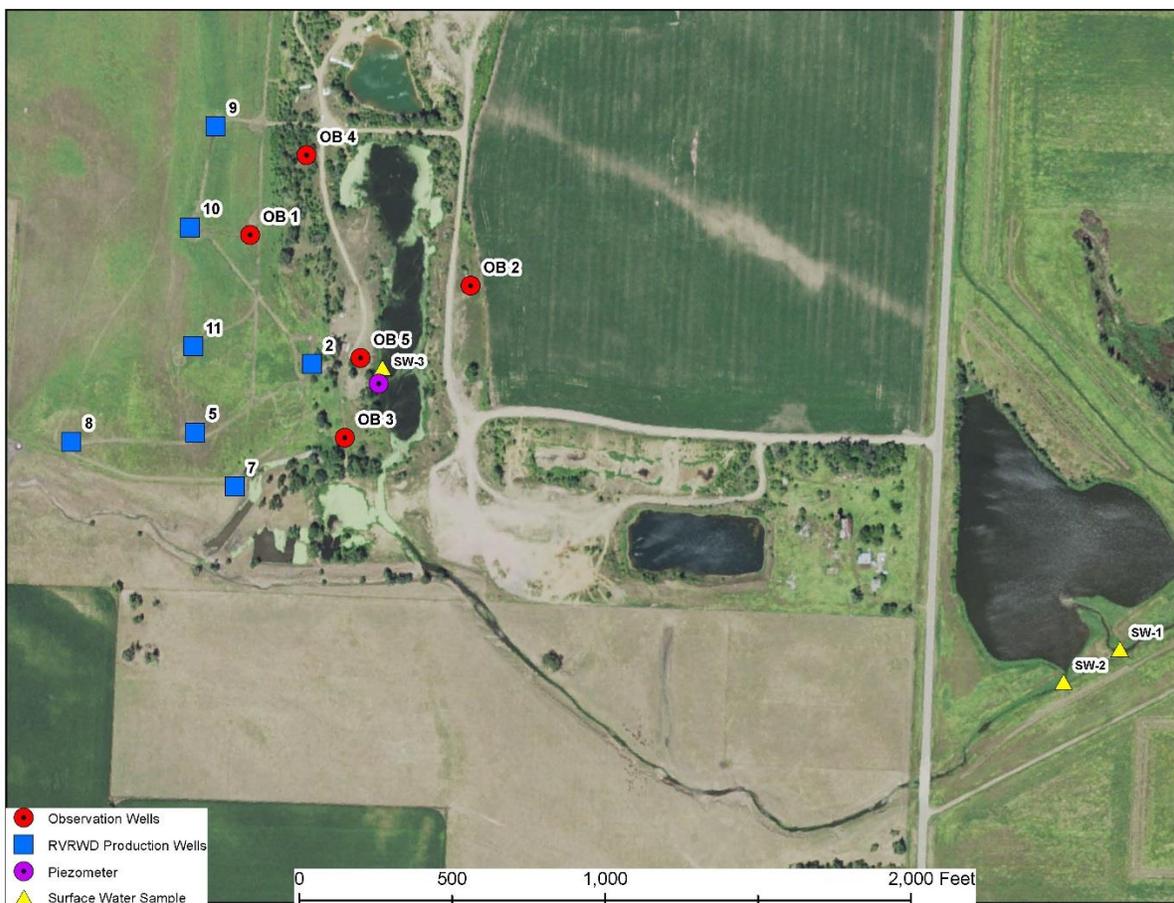
Figure 3. Rock Valley Rural Water District wellfield showing the location of existing observation well OB1, four new observation wells OB2, OB3, OB4, and OB5, and surface water sample locations SW1, SW2, and SW3.

On November 4, 2015, four additional observation wells (OB2, OB3, OB4, and OB5) were installed as shown on Figure 3. The wells consisted of 2-inch diameter schedule 40 PVC, and were screened from 30 to 40 feet using 0.010 slot screen. Driller’s logs and well construction diagrams are shown in Appendix A. A steel protective casing was also used for each well to complete the installation. The top of the PVC casing elevation for each new observation well, one existing observation well (OB1), and one piezometer (PZ-1-installed near SW-3) were surveyed using a David White transit and survey rod. The top of Production Well 10 was used as the datum elevation.

Monthly water levels were measured starting in November of 2015 using an In-Situ electronic water level probe. The monthly water levels and groundwater elevations are shown in Appendix B. Water samples were also collected monthly from each observation well and piezometer location using a peristaltic pump. In addition, water samples were collected in the Unnamed Creek upstream and downstream of Solberg pond, in the recharge basin, and in RVRWD Production Wells 2, 7, 9, and 10 (Figure 3). Samples were analyzed for nitrate as nitrogen and total chloride. All of the sampling locations are shown in Figure 3.

Water samples were collected monthly from the five on-site observation wells, the RVRWD production wells 7, 9, 10, and 11, the Unnamed Creek both upstream and downstream of Solberg Pond, and the recharge basin. Samples were analyzed for nitrate as nitrogen and total chloride. Figures 14, 15, and 16 show the nitrate as nitrogen concentrations throughout the 12 month period for the surface water samples, the observation wells, and the production well samples. The wells and surface water sampling locations are shown in Figure 3.

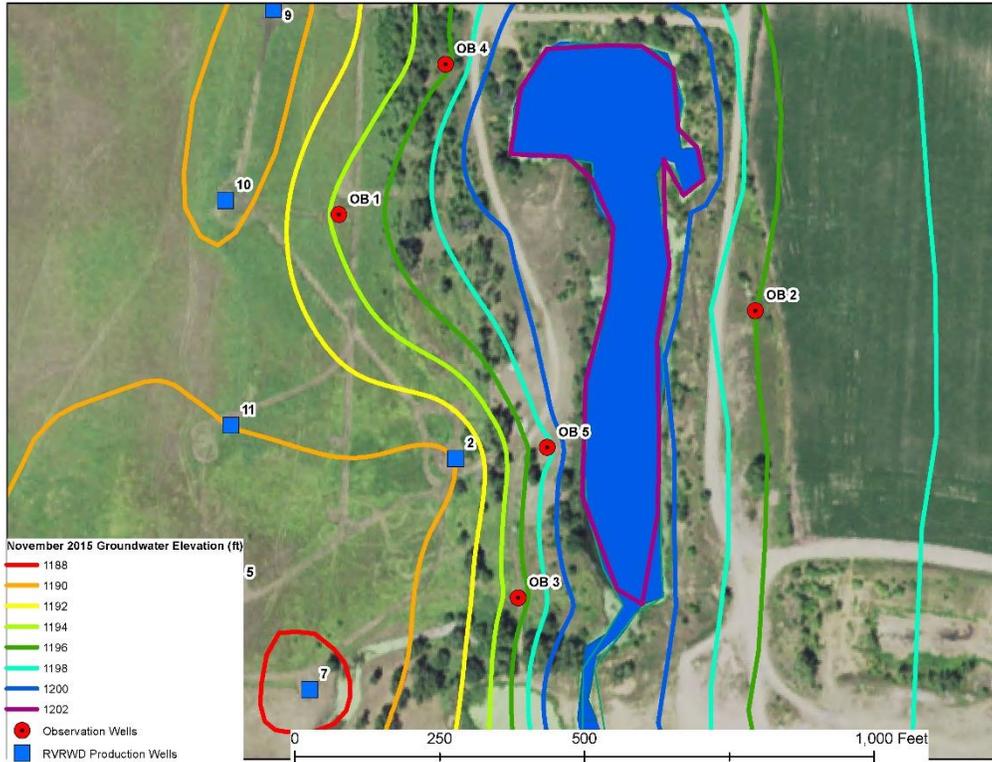
Figure 4. Observed groundwater elevation contour map for November 2015.

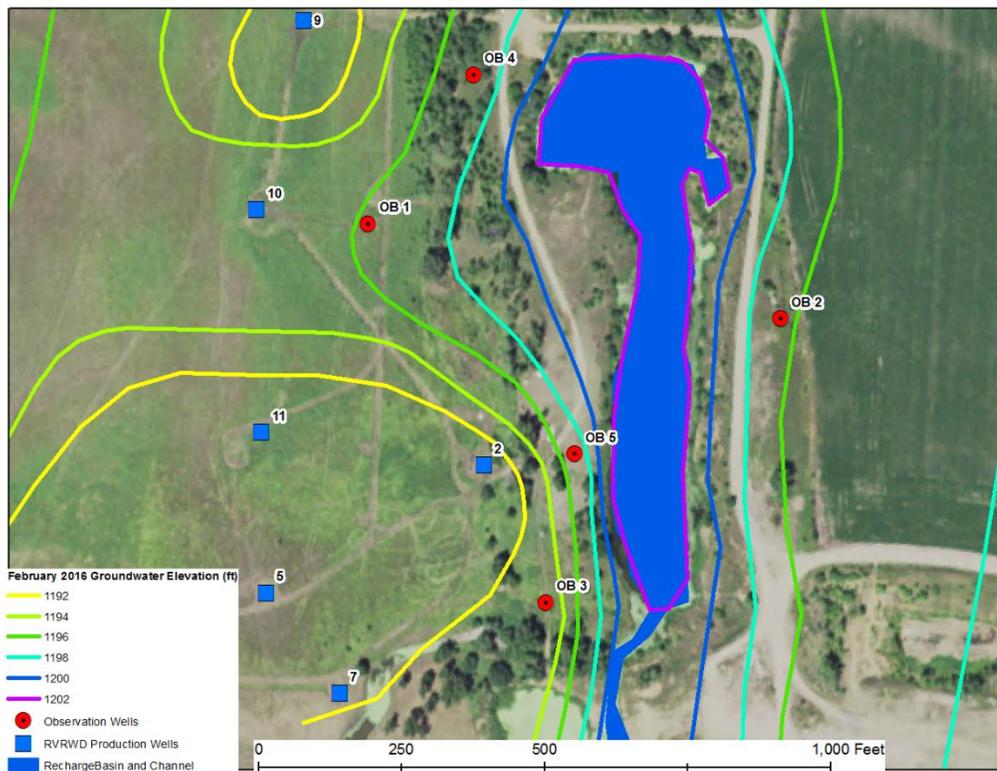
Figure 5. Observed groundwater elevation contour map for February 2016.

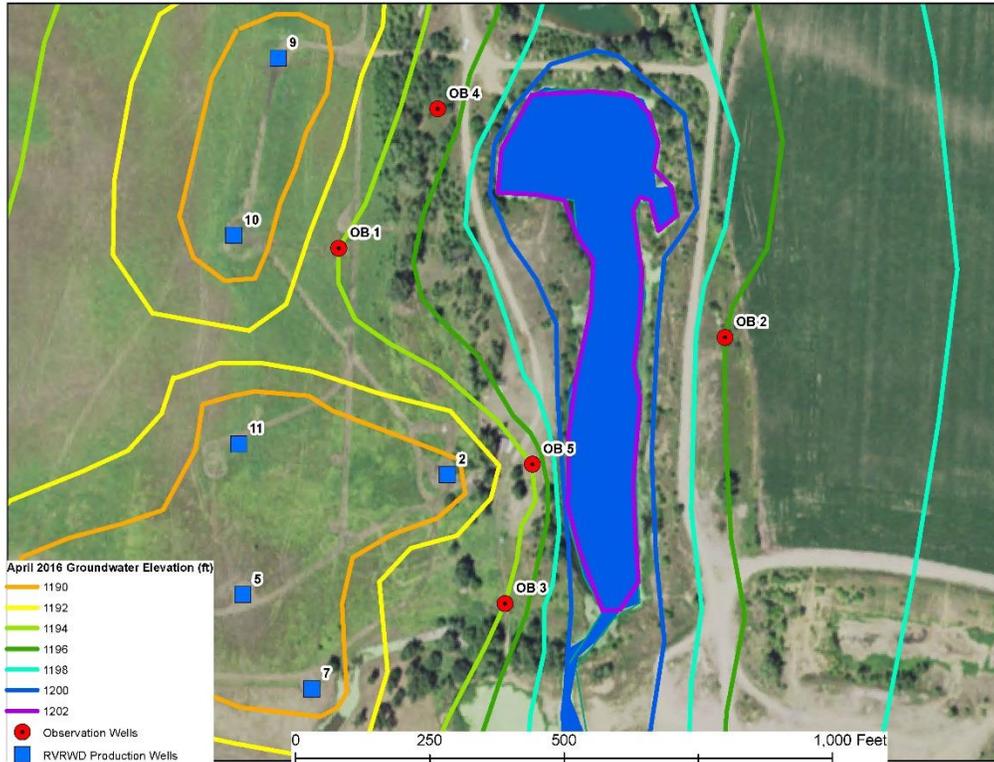
Figure 6. Observed groundwater elevation contour map for April 2016.

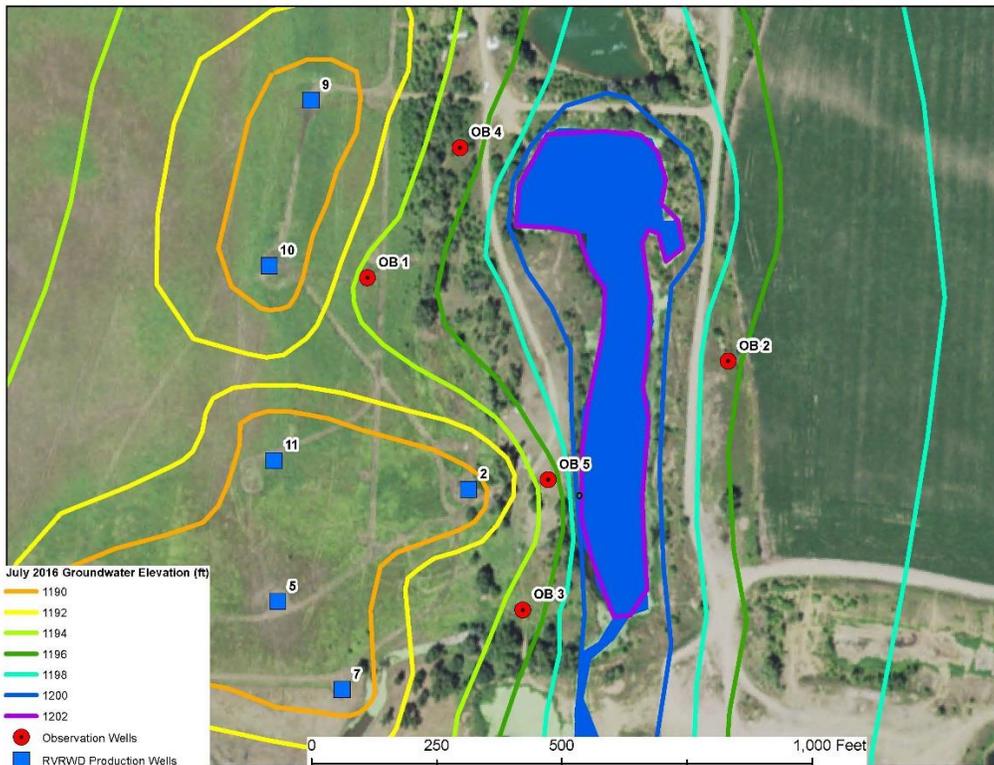
Figure 7. Observed groundwater elevation contour map for July 2016.

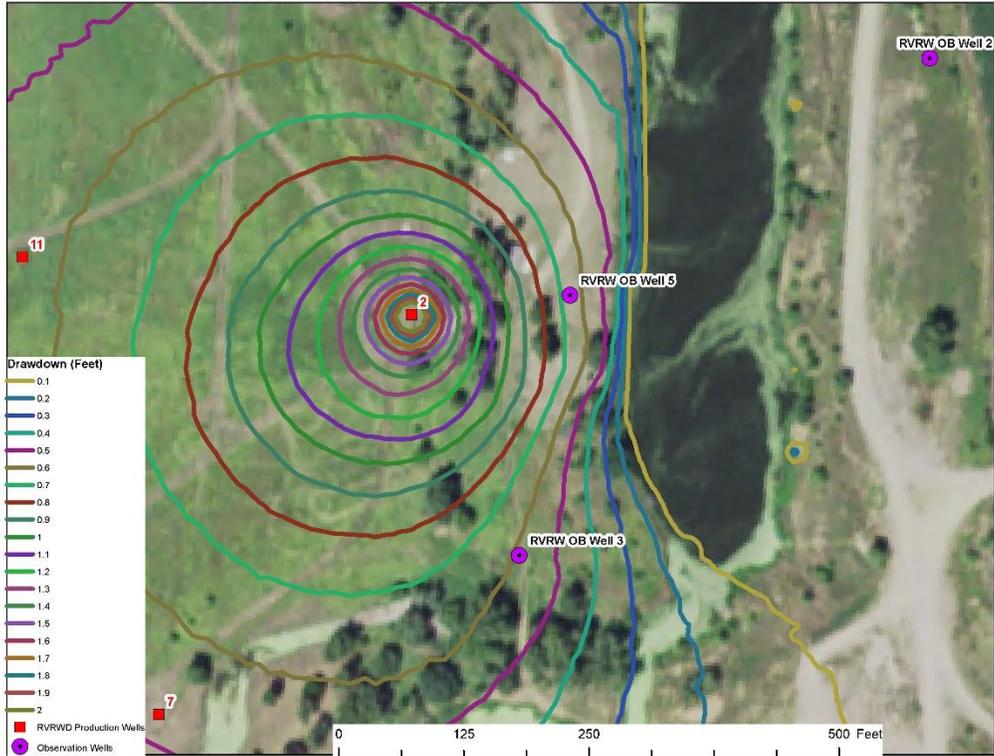
Figure 8. Simulated drawdown contours for aquifer pump test Well 2-Observation Well OB5.

The model developed in 2014 (Gannon and Vogelgesang, 2014) was recalibrated using the pump test data collected from September 27 through September 28, 2016. Total observed drawdowns in the observation wells ranged from 0.28 feet in observation well OB4 to 0.697 feet in observation well OB5. Hydraulic conductivity values were adjusted to match the simulated drawdowns to the observed values. Figures 8, 9, and 10 show the simulated drawdown values from the aquifer pump tests. The simulated versus observed drawdowns are presented in Table 1.

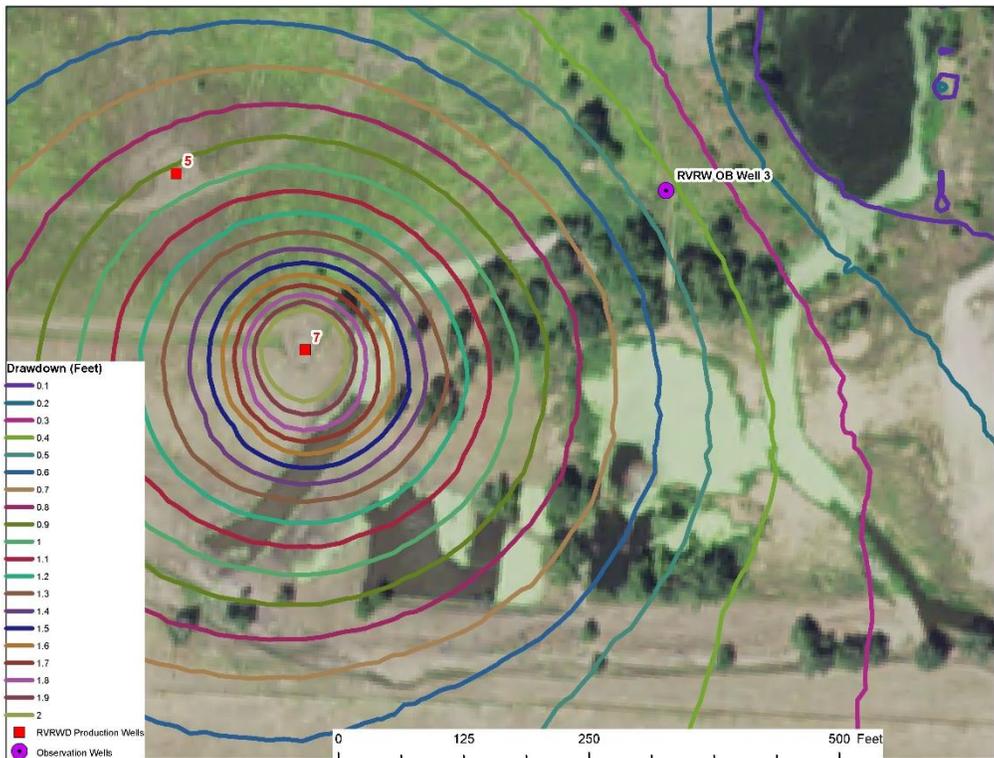
Figure 9. Simulated drawdown contours for aquifer pump test Well 7-Observation well OB3.

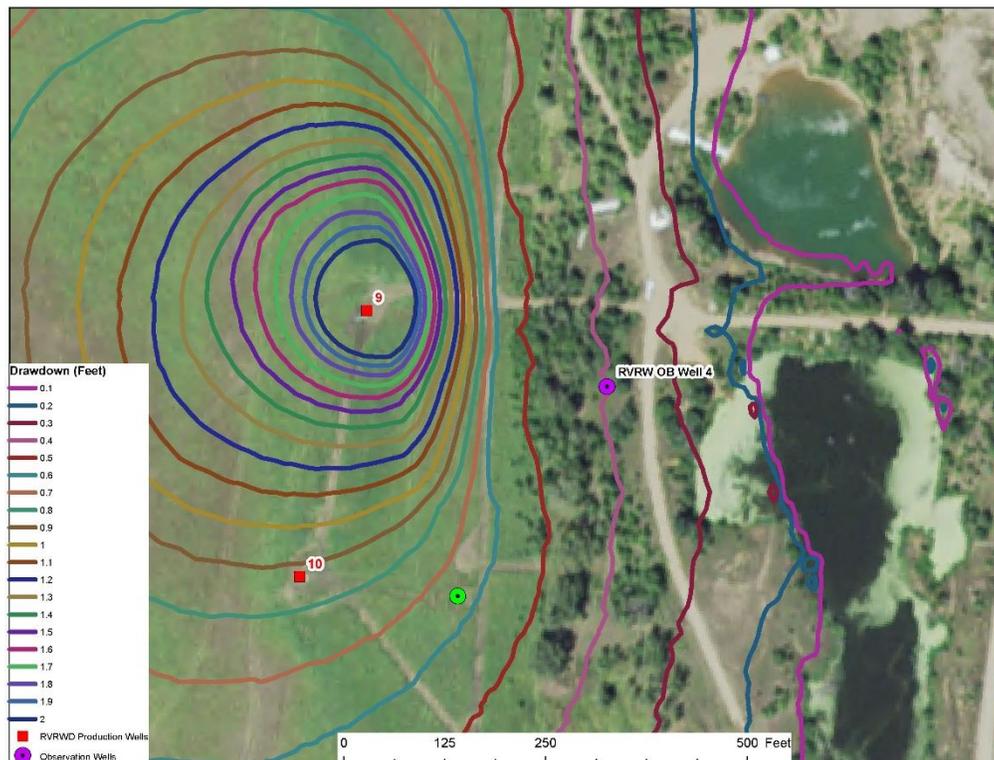
Figure 10. Simulated drawdown contours for aquifer pump test Well 9-Observation well OB4.

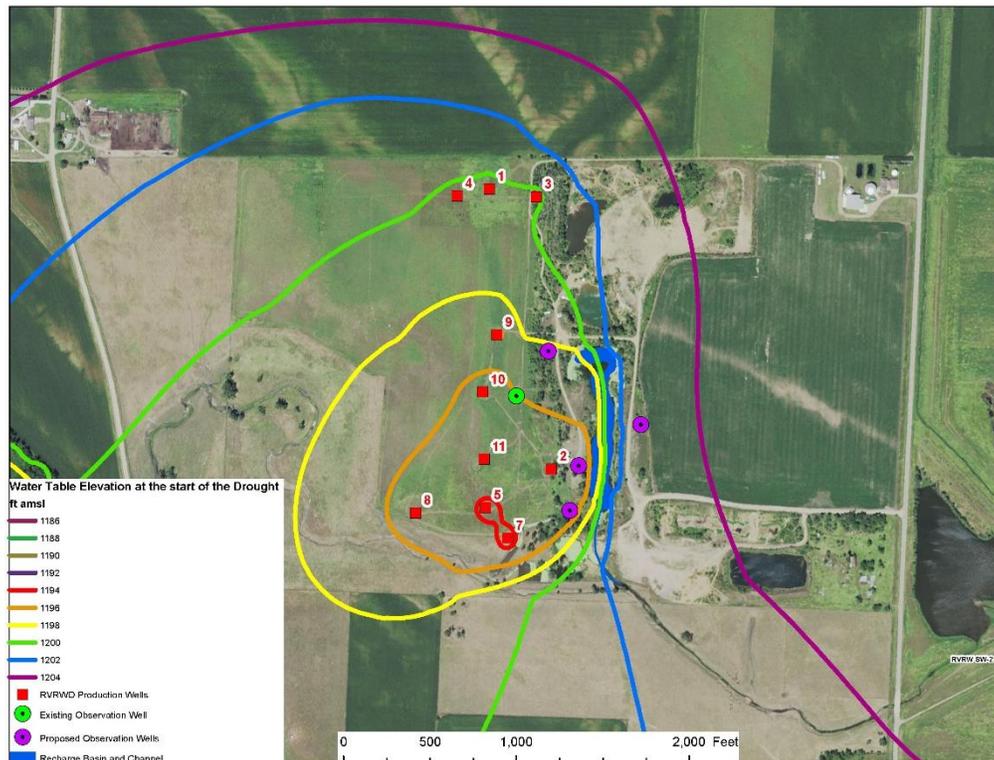
Figure 11. Simulated groundwater elevation contours at the start of a 2-year severe drought.

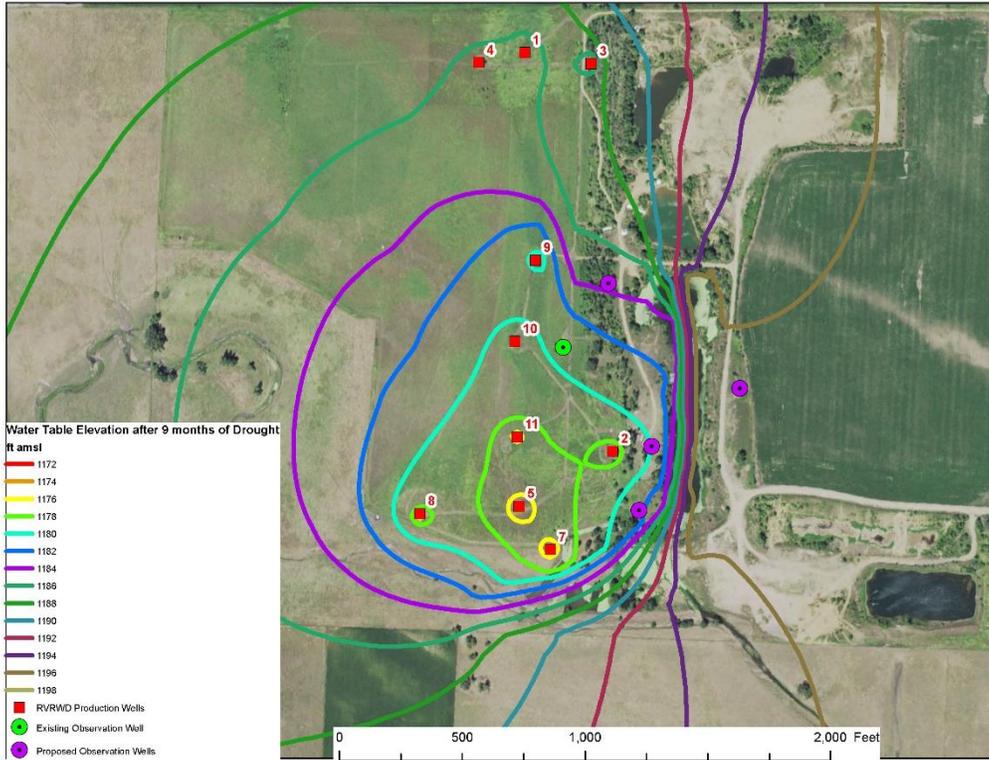
Figure 12. Simulated groundwater elevation contours after 9 months of a 2-year severe drought.

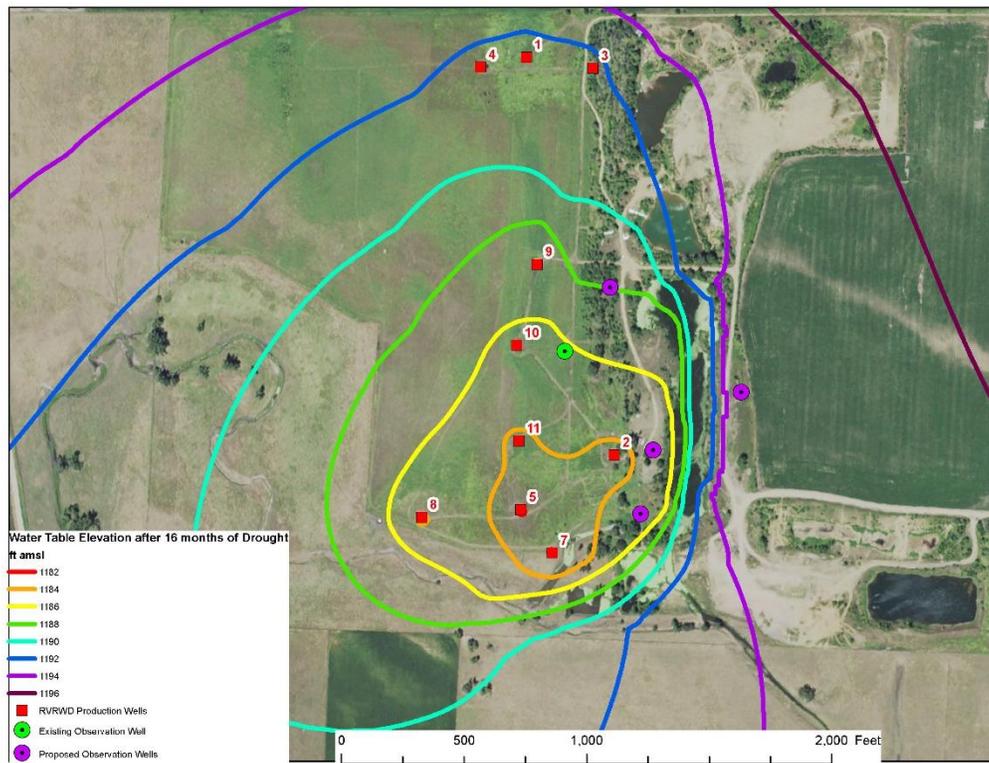
Figure 13. Simulated groundwater elevation contours after 16 months of a 2-year severe drought.

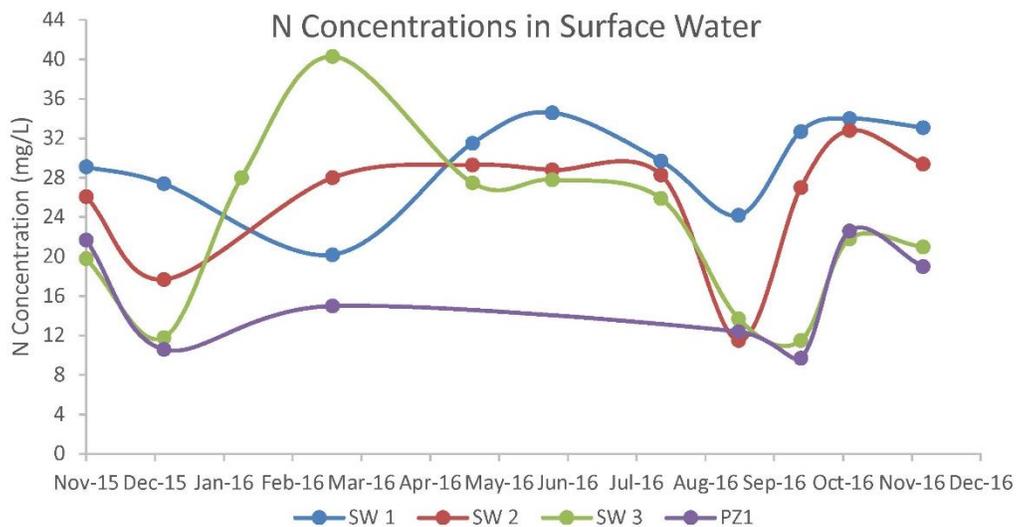
Figure 14. Monthly nitrate as nitrogen concentrations measured in the surface water sample locations for November 2015 through November 2016.

Based on Figure 14, nitrate concentrations in Unnamed Creek tends to be higher upstream (SW1) of Solberg pond than downstream (SW2), except for water samples collected in January and February 2016. The water samples collected during January and February may have been influenced by the abnormally high precipitation and flooding that occurred during the months of November and December. The slug of nutrient-rich water entering the Pond may have caused higher concentrations coming out of Solberg Pond than entering the Pond during the months of January and February. If January and February are excluded, reduction of nitrate appears to be occurring in Solberg Pond.

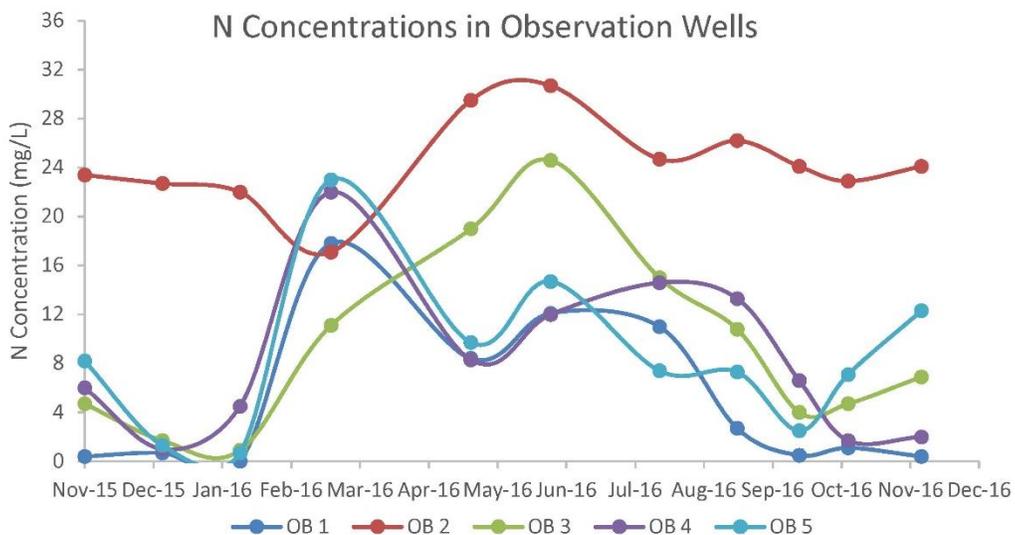
Figure 15. Monthly nitrate as nitrogen concentrations measured in the surface water sample locations for November 2015 through November 2016.

Based on Figures 15 and 16, the nitrate as nitrogen concentrations in both the on-site observation wells and the RVRWD production wells fluctuate seasonally, with the highest concentrations generally occurring during the winter and early spring months. The seasonal fluctuation in nitrate concentrations in the shallow groundwater is strongly influenced by the nitrate concentration within the recharge basin. The flooding that occurred during the late fall and early winter of 2015 resulted in nitrate as nitrogen concentrations of over 40 ppm within the recharge basin.

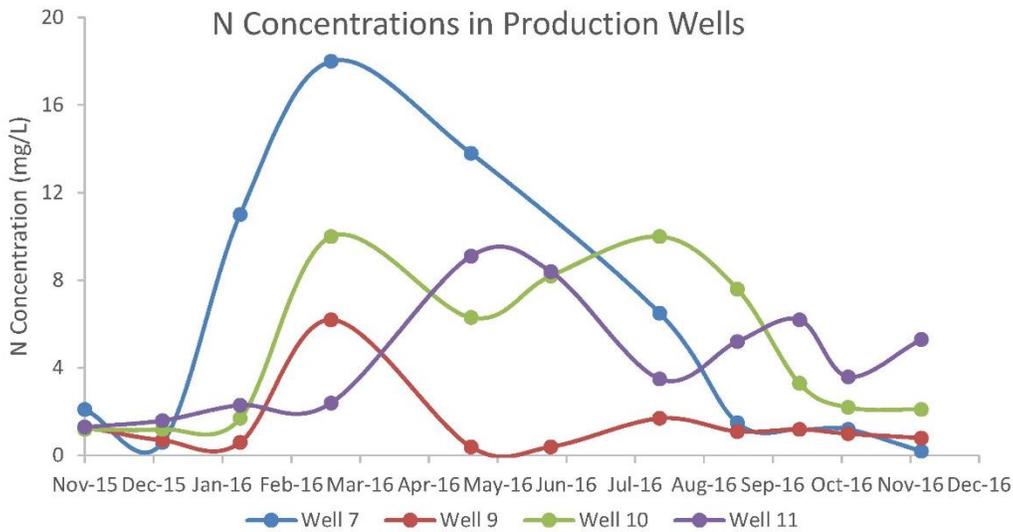
Figure 16. Monthly nitrate as nitrogen concentrations measured in the RVRWD production wells for November 2015 through November 2016.

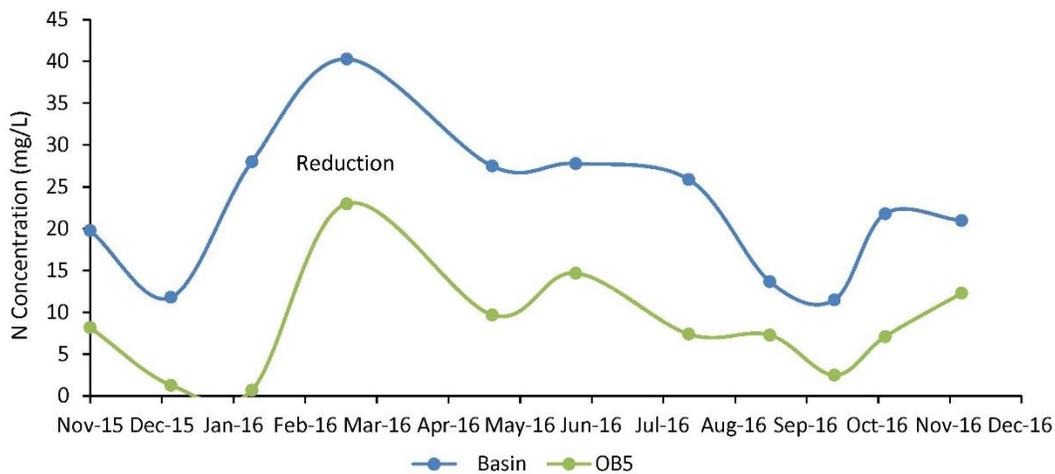
Figure 17. Monthly nitrate as nitrogen concentrations measured in the recharge basin and in the shallow groundwater downgradient of the basin.

The monthly nitrate as nitrogen concentrations in the recharge basin and in water samples collected in downgradient observation well OB5 is shown in Figure 17. Observation well 5 is the closest downgradient well to the recharge basin. Nitrate concentrations in the shallow groundwater directly

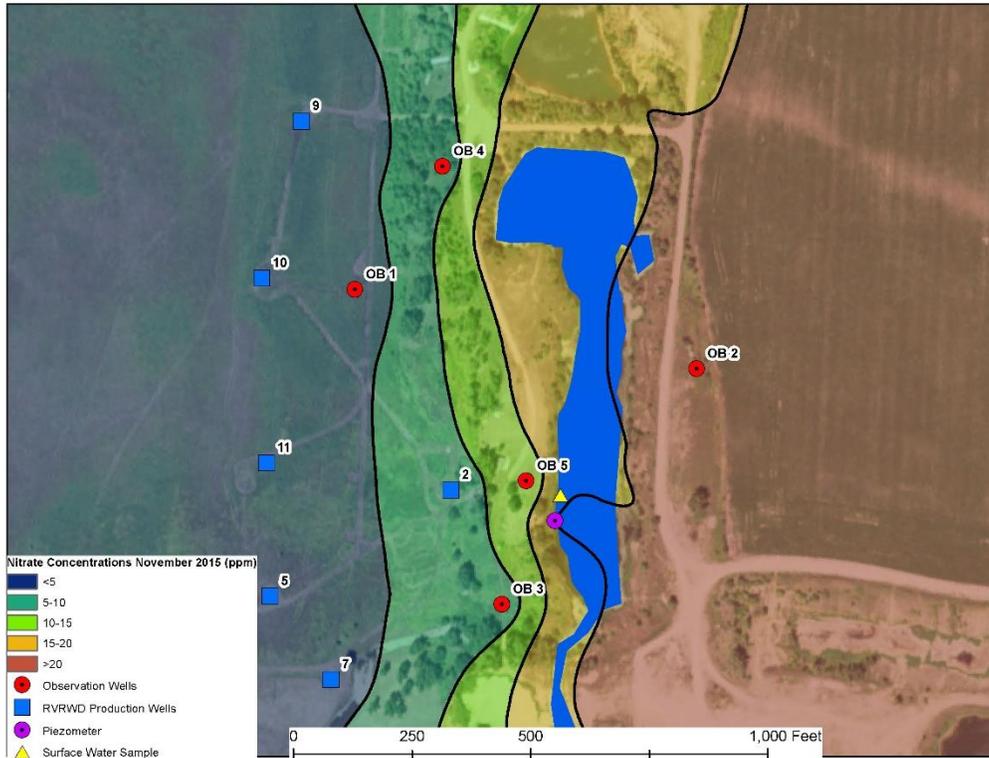
Figure 18. Nitrate as nitrogen concentrations near the RVRW wellfield in November 2015.

Figures 18, 19, 20, and 21 show the nitrate as nitrogen concentrations for the months of November 2015, February 2016, April 2016, and July 2016 surrounding the RVRWD wellfield. The impact of the late fall 2015 flooding is apparent in Figure 19 where nitrate concentrations of over 40 ppm were observed in the recharge basin during the month of February. The induced recharge from the basin was observed to migrate quickly downgradient toward the observation wells and eventually to the production wells. The pumping stress created by the RVRWD production wells further increased the hydraulic gradient, which enhanced the migration of the nitrate plume to the west.

Based on the observed data as shown in Figures 18, 20 and 21, the nitrate as nitrogen concentrations within the shallow groundwater tend to decrease during the spring, summer, and fall months. This downward trend in nitrate concentrations is related to several factors. One factor has been discussed previously, and involves the increase in low-nitrate precipitation recharge, which mixes with the induced recharge from the basin. A second factor that may explain the downward trends in nitrate concentrations during the spring, summer and fall months may be related to the biological uptake by riparian zones along the basin shoreline and aquatic plants during the growing season.

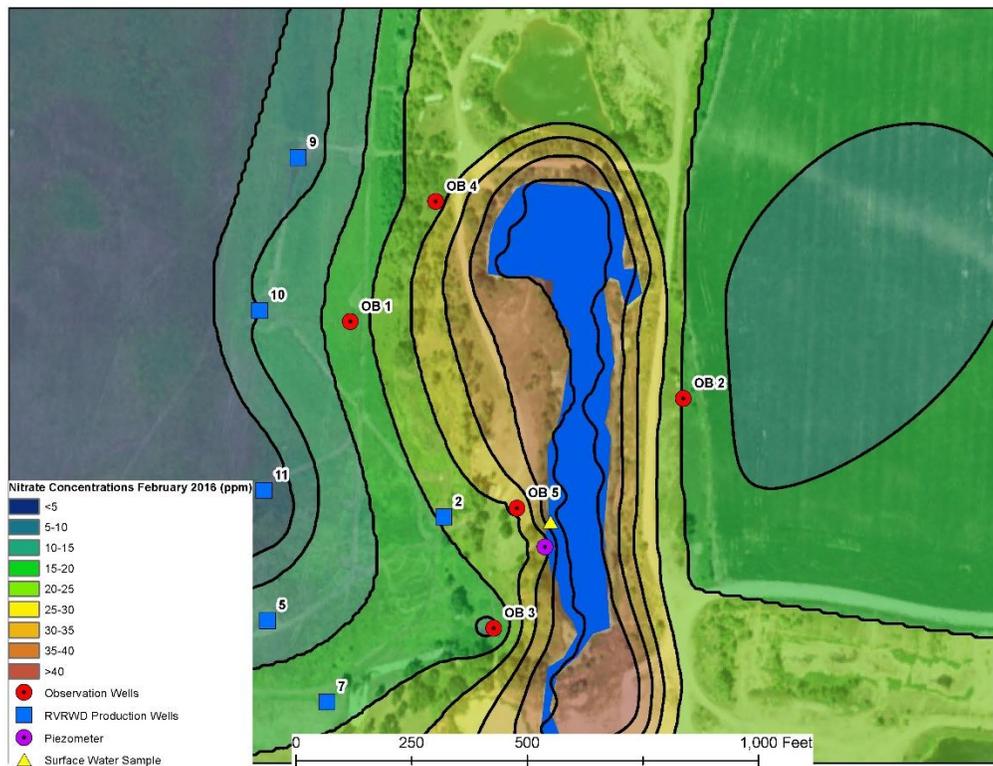
Figure 19. Nitrate as nitrogen concentrations near the RVRW wellfield in February 2016.

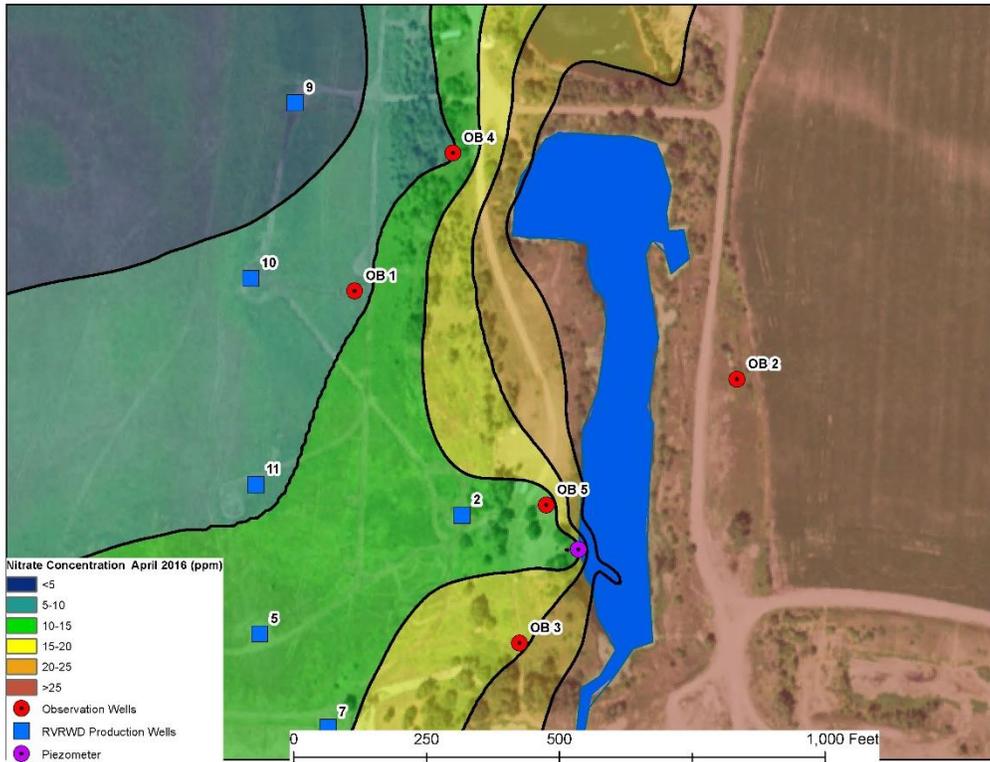
Figure 20. Nitrate as nitrogen concentrations near the RVRW wellfield in April 2016.

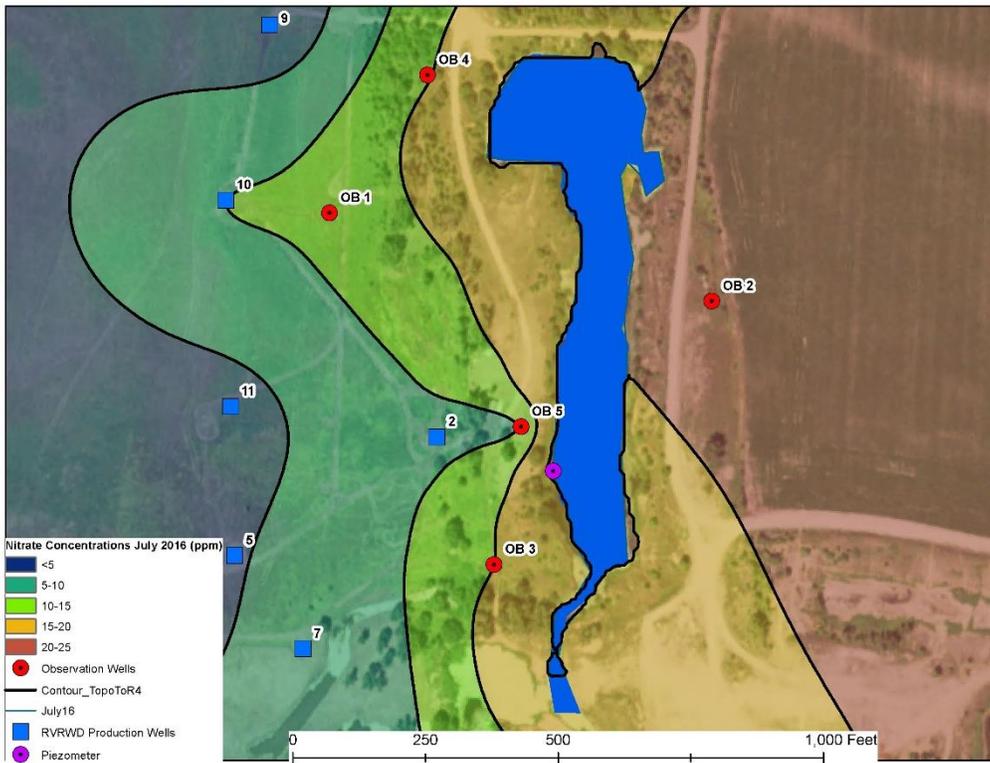
Figure 21. Nitrate as nitrogen concentrations near the RVRW wellfield in July 2016.

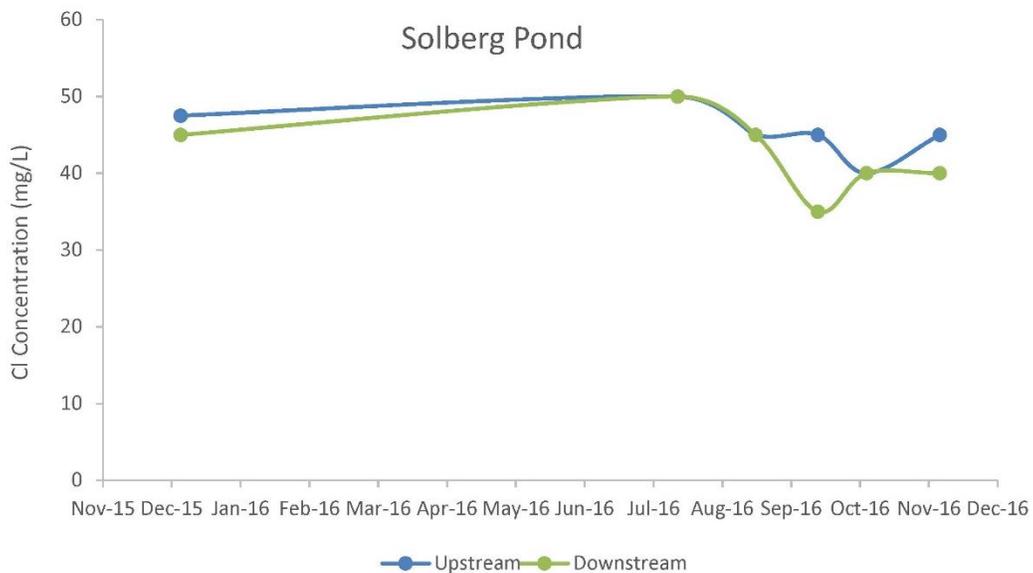
Figure 22. Monthly total chloride concentrations in Unnamed Creek upgradient and downgradient of Solberg Pond.

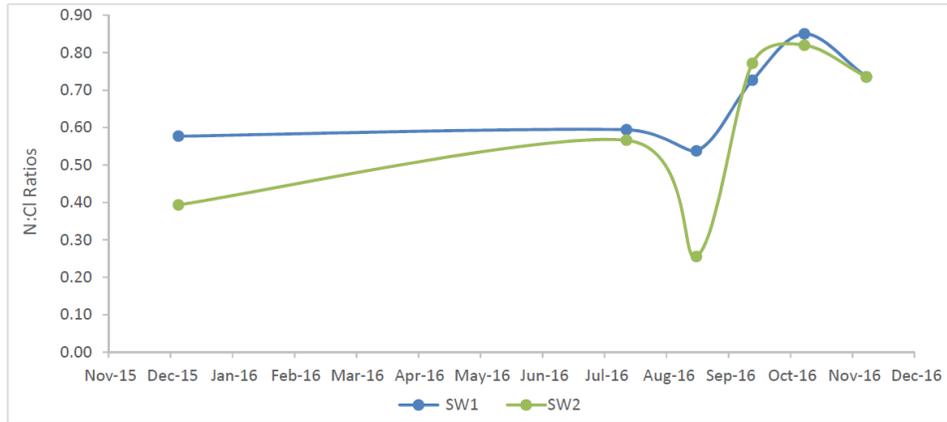
Figure 23. Nitrate-Chloride ratios in samples collected in Unnamed Creek upgradient and downgradient of Solberg Pond.

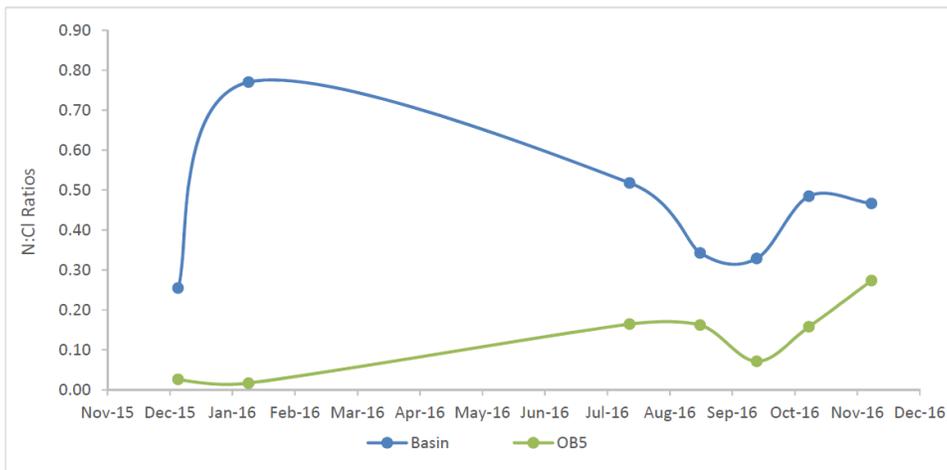
Figure 24. Nitrate-Chloride ratios in samples collected in the recharge basin and in downgradient observation well OB5.

Based on Figure 24, the nitrate/chloride ratio in the water from the recharge basin is much higher than the groundwater sampled from downgradient observation well OB5. The biological reduction within the basin sediments appears to reduce the nitrate concentrations, but the chloride concentrations remain relatively unchanged as shown in Figure 25. Based on the nitrate/chloride ratios, the primary nitrate reduction process shown in Figure 17 and quantified in Table 4 is attributed to biological reduction.

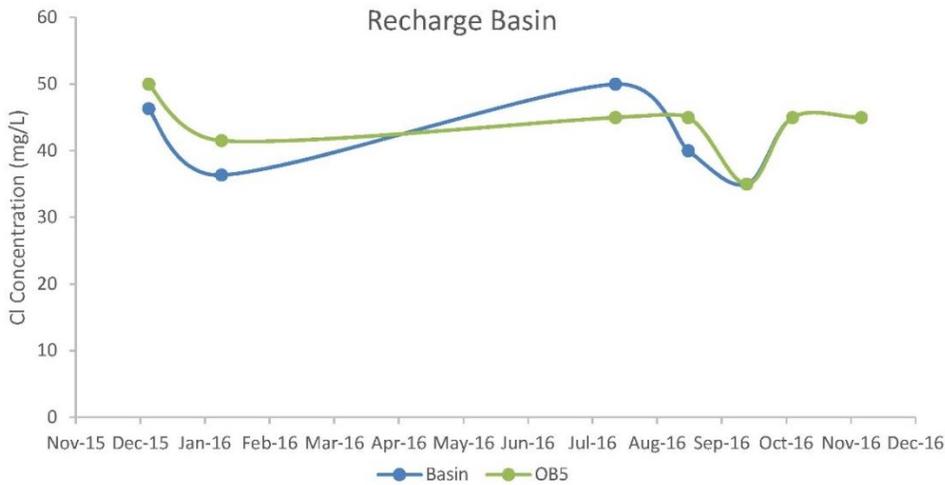
Figure 25. Total chloride concentrations in samples collected in the recharge basin and in downgradient observation well OB5.

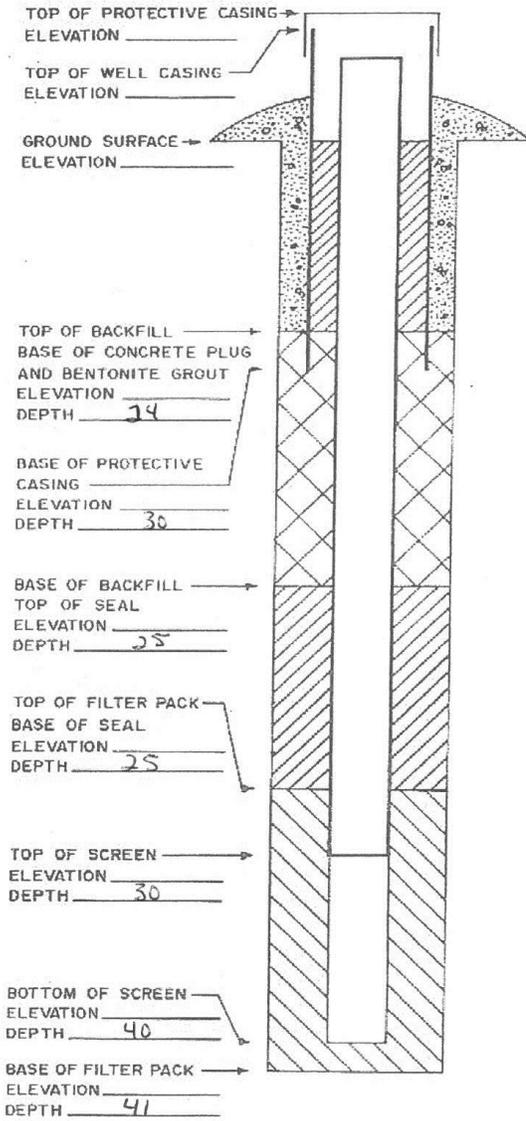
0 - 2' Sandy Topsoil
 2' - 40' med Sand

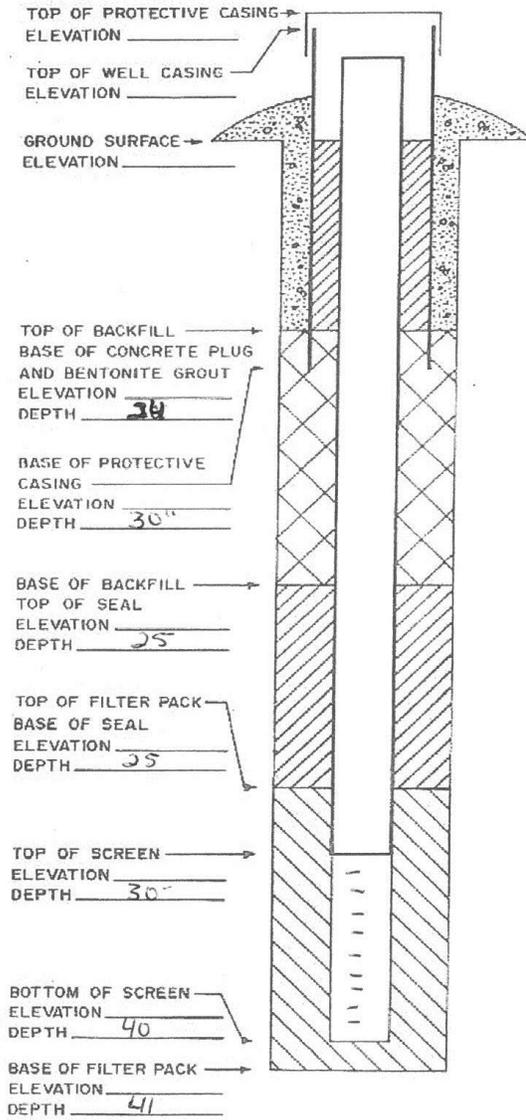
0-3 Sandy Topsoil
 3-41 med. Sand

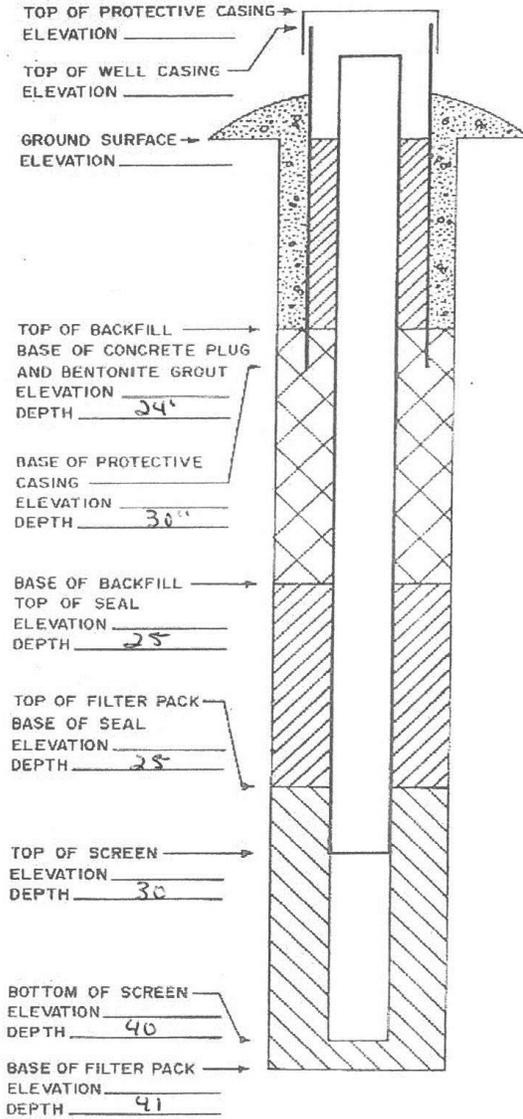
0 - 2 Sandy Top Soil
 2 - 20 med. Sand
 20 - 30 Large Cobbles
 30 - 40 Cobbles & med Sand

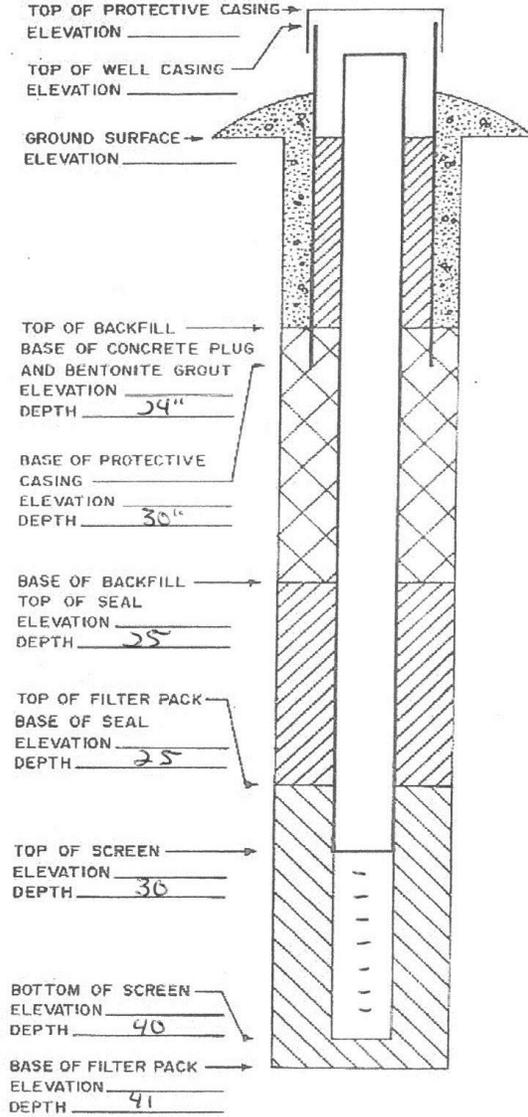
0-2" Black Top Soil
 2-15' Brown Clay
 15-30 med. Sand
 30-40 Cobbles & med Sand
