Investigation of a Recharge Basin to Improve Drought Resiliency and Aquifer Sustainability

Rock Valley Rural Water

Water Resources Investigation Report 15

Iowa Geological Survey
Water Resources Investigation Report 15

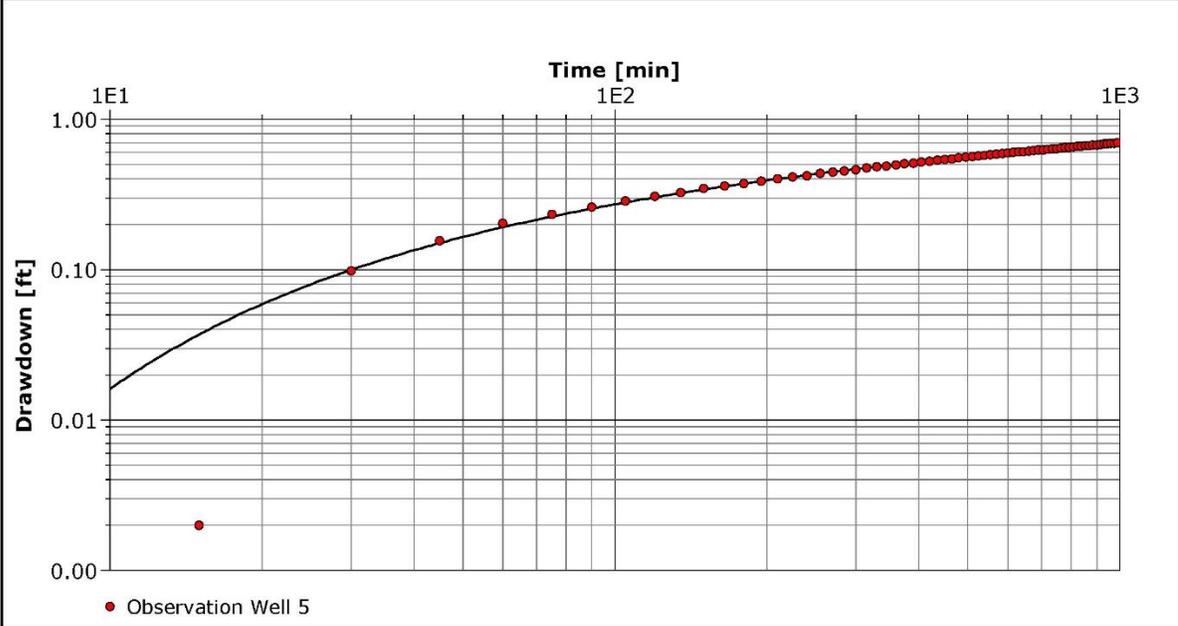
| Aquifer Thickness: 40.00 ft | Discharge Rate: 425 [U.S. gal/min] | |

Calculation using Theis

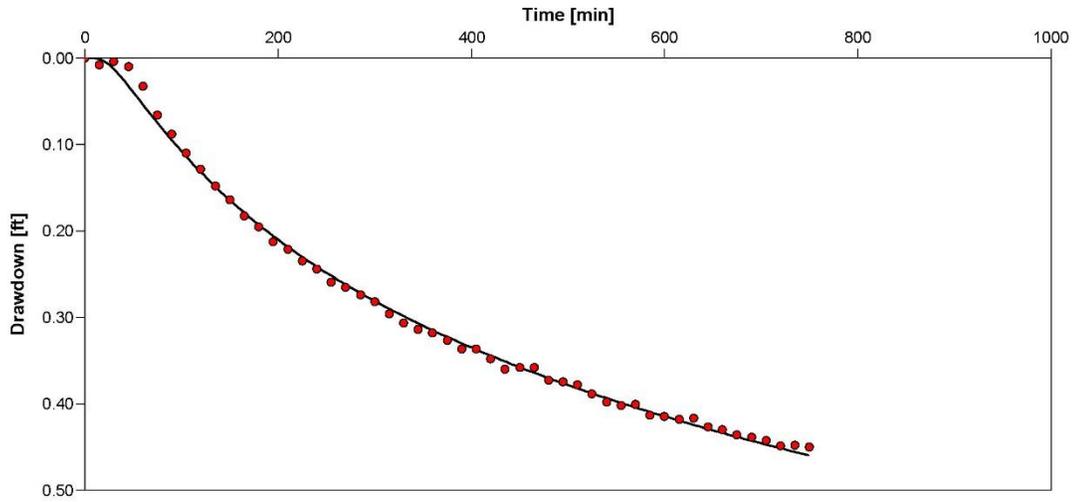
| Aquifer Thickness: 40.00 ft | Discharge Rate: 200 [U.S. gal/min] | |

| Calculation using Theis | | | | | |

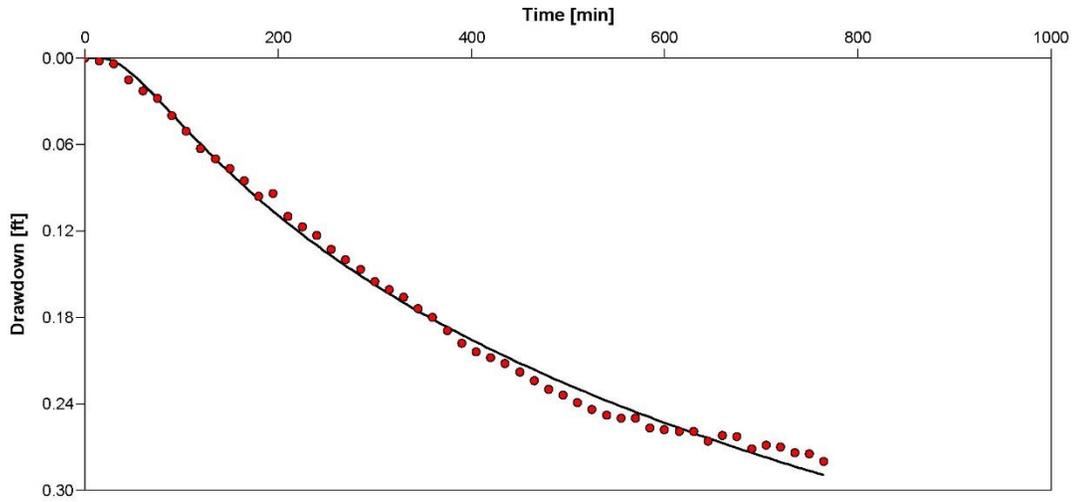
| Aquifer Thickness: 40.00 ft | Discharge Rate: 450 [U.S. gal/min] | |

| Calculation using Theis | | | | | |
